***CONDITION INSPECTION SURVEY***

***Snowgoose 37***

***“Catalyst”***

***Ben Sutcliffe-Davies AssocIIMS***

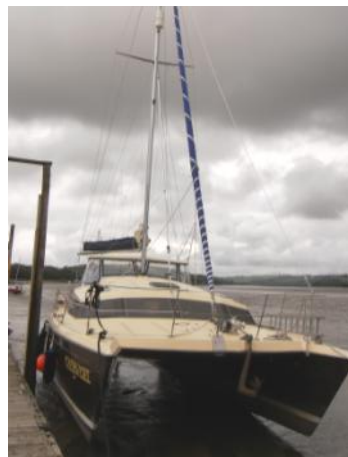
**Craft at time of reinspection.**

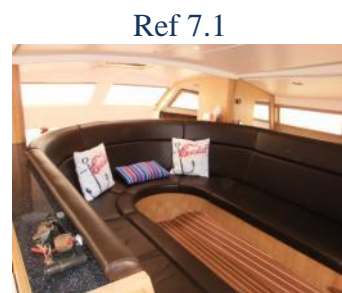
New fitted saloon.

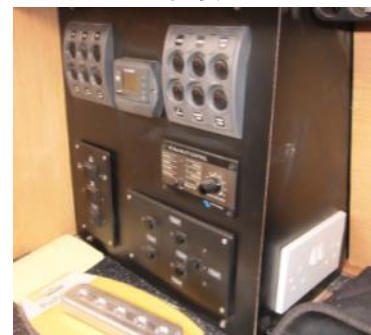
Ref 9.1

**9.1 Crafts Electrics.** The craft now has been fitted with a bank of three heavy duty 12v Optima spiral batteries. They are all position within the port hull aft under the bunk unit. The forth is fitted in the bow area for the anchor winch. The whole electrical system has been completely replaced. The switch gear position if fitted to a very high standard and very clear. There are two electric units one to deal with shore power with the second dealing with the crafts 12v system. The whole installation, Wiring, Inverter, Control switches etc are all clipped and supported appropriately. The batteries are suitably secured with a method of venting the area.

New switch gear etc.

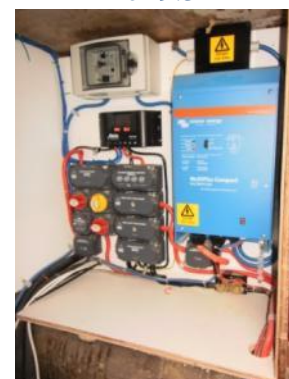
Ref 9.3

Complete new shore power system fitted.

**9.3 Shore power.** There is a good quality new shore power system fitted. There is a new RCD unit fitted with a complete new fuse board and set of switch gear fitted. All cabling is new and of the correct flexible type for marine applications. There were no shore power points available at her berth to test the system. The craft also has an inverter fitted to power the micro wave within the galley if required. All satisfactory.

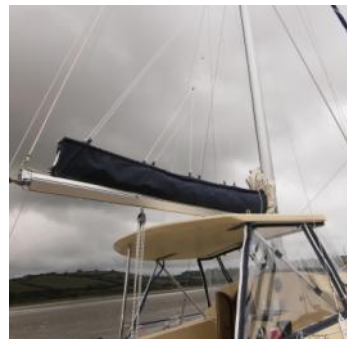
Ref11.1-11.4

**11.1 Mast/ Boom.** The rig is a mast head rig. The sections are made by Proctor Spars and were originally black anodised. Both sections have now been fully refurbished and sprayed in silver. They are in good condition and straight with no signs of damage or corrosion. There is an encapsulated mast head radar reflector fitted to the mast. There are a new set of wind instruments etc fitted to the mast head. The craft also has a pair of roller furling systems also fitted.

**11.2** The mast and spars have been fully re rigged to a high standard with new Stainless steel standing rigging and new good quality multi plat running rigging including mast head halyards, main sheets, vang, genoas etc. I did inspect the stays and running gear as best as I could, there is no obvious damage to any of the rigging. Most of the shrouds are correctly tensioned. Most of the rigging screws have lock nuts and most have split pins. Only the aft shrouds were missing split pins and should be addressed prior to using the craft. *Fit split pins or clevis rings as necessary.*

Fully upgraded spars and new rigging.  
New Cockpit cover.
